Biodentine[®]

Dentin Substitute

Biodentine[®]: Save the root, Save the tooth

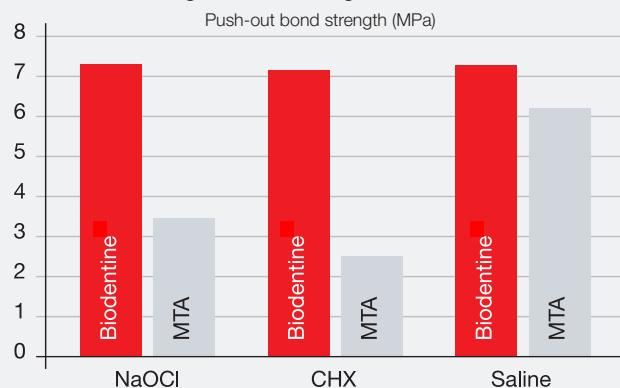
Biodentine shows higher resistance to dislodgement, regardless of the irrigation solution

Source : Guneser et al., JOE, 2013

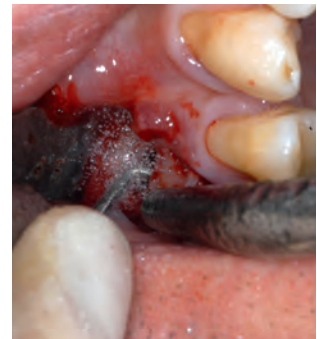
Both mesiobuccal root canals were retrogradely prepared and cleaned with an angled, diamond-coated ultrasound probe.

For successful apicoectomy, retrograde sealing of resected root canals is essential because gutta-percha alone is known not to be capable of inducing osseous regeneration at the root tip. Biodentine shows a positive effect on osseous cells and allowed, in this case, complete osseous regeneration 6 months after treatment. ⁽³⁾

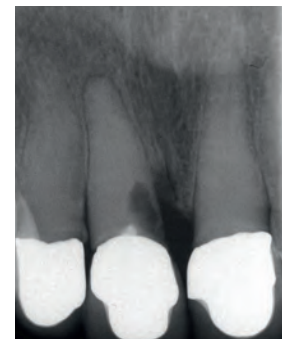
Initial X-ray findings with cervical root defect.

Cervical root resorption mostly occurs directly beneath the epithelial attachment and is caused ultimately by an injury to the periodontium.

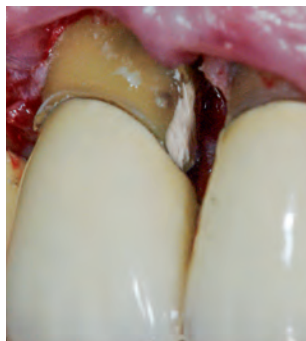
Closure of the cavity with Biodentine.

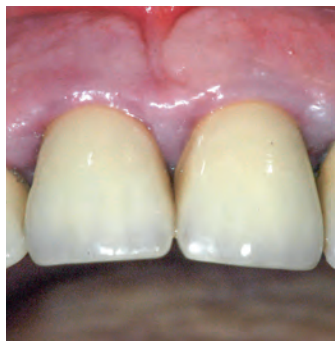
Clinical picture after 12 months.
